Turfgrass and Environmental Research Online

Volume 5, Number 8
April 15, 2006

Nutrient Runoff from Three Phases of a Golf Course Project

Steve Starrett, Yunsheng Su, Travis Heier, Jamie Klein, and Jeff Holste

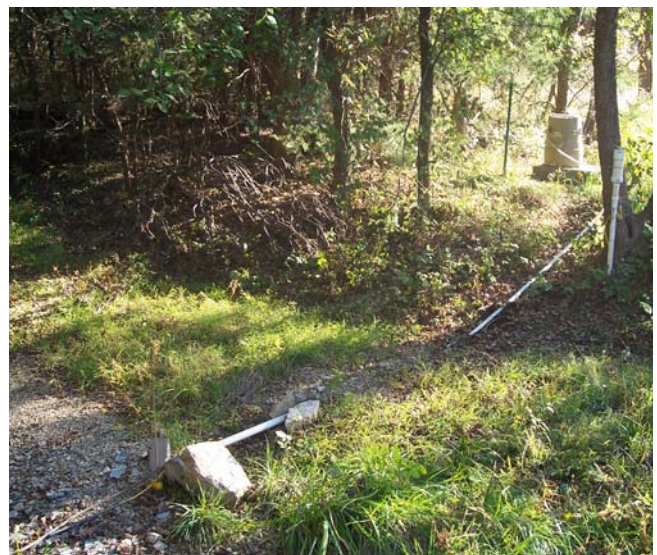
Sampling equipment was obtained, and three monitoring stations were set up to monitor the impacts of construction and operation of the golf course on surface water quality.

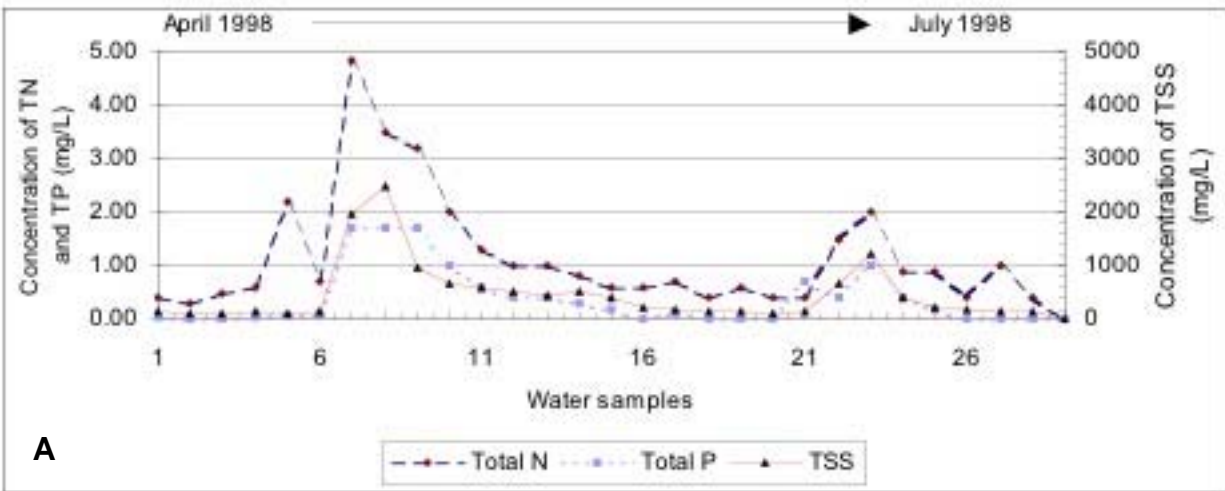
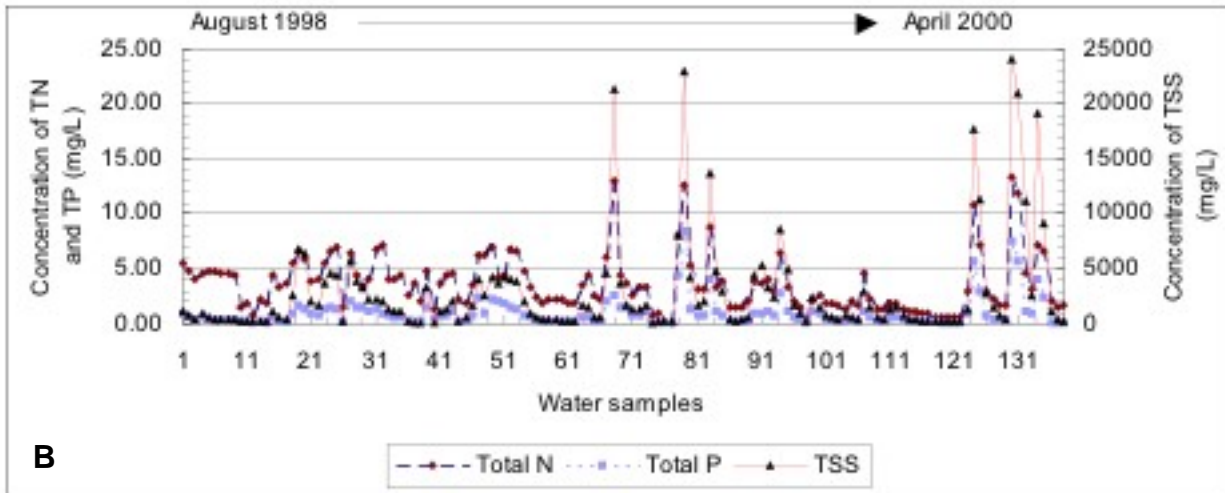
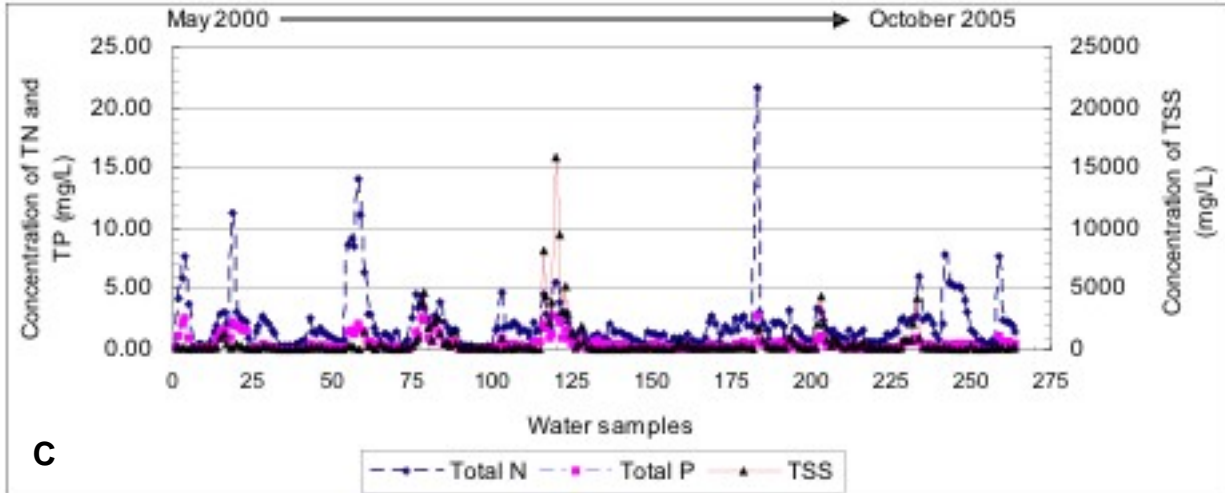
Figure 5. Concentrations of TN (total nitrogen), TP (total phosphorus), and TSS (total suspended solids, sediment) during pre-construction (A), during construction (B), and during early operation after construction (C).

Concentrations of TN, TP, and TSS over time are plotted in Figure 5. From these three figures, differences in TN, TP, and TSS are obvious. The linkage of TSS concentration and both TN and TP is also evident. When TSS spikes, so does TN and TP. It is also obvious that the construction phase is most vulnerable to nutrient loss. Take TN as an example. During the pre-construction phase, maximum values for TN are about 5 mg/L with most of the values around 1 mg/L. During construction, TN is commonly found in runoff water at 4-5 mg/L with the maximum value at about 13 mg/L. During operation, the majority of values are around the 1-2 mg/L range with a few samples exhibiting higher amounts.
