Turfgrass and Environmental Research Online

Volume 5, Number 8
April 15, 2006

Nutrient Runoff from Three Phases of a Golf Course Project

Steve Starrett, Yunsheng Su, Travis Heier, Jamie Klein, and Jeff Holste

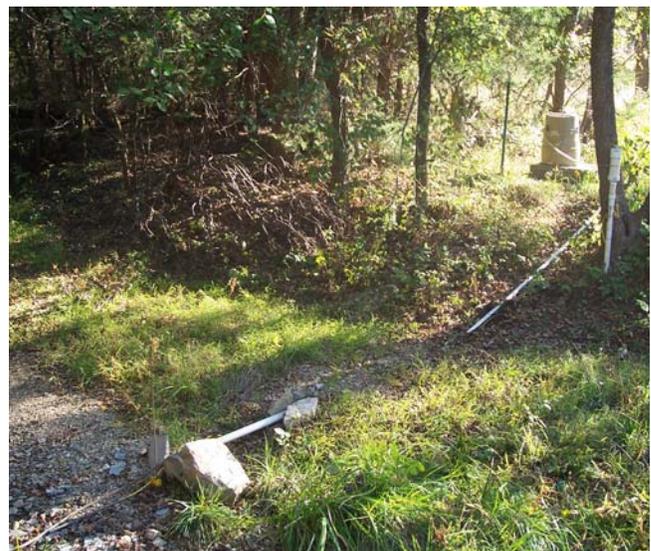
Sampling equipment was obtained, and three monitoring stations were set up to monitor the impacts of construction and operation of the golf course on surface water quality.
