Reducing Watershed Scale Phosphorus Export through Integrated Management Practices

Kevin King, USDA-ARS James Balogh, Spectrum Research, Inc.

Turfgrass and Environmental Research Online Volume 12, Number 2 | March–April 2013

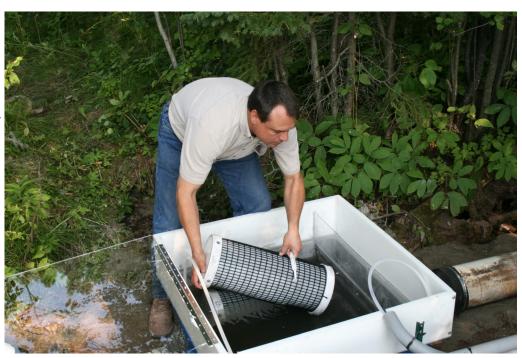
Figure 1. Filter cartridges are being evaluated for filtering phosphous from leaving a golf course property.

Discharge and water quality samples are collected by a combination of grab samples and automated sample collection. In the spring of 2004, two tile lines responsible for draining the majority of the study area were instrumented with compound weirs and bubbler flow meters to determine flow rate. In 2009, a commercialized end-of-tile filter was installed on the

outlet of the east drain. All sites are equipped with Isco 6712 automated samplers and programmed to collect discrete flow proportional samples.

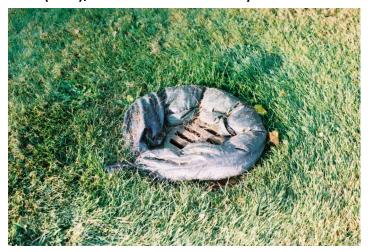
Figure 2. Filter socks were installed around each inlet within the eastern drainage area. The filter socks were filled with 75% steel slag, 2.5% cement kiln dust (CKD), and 22.5% silica sand by volume.

In March of 2011, we initiated a paired study with the east and west drains and installed filter socks around each inlet within the eastern drainage area. The filter socks were filled with 75% steel slag, 2.5% cement kiln dust (CKD), and 22.5% silica sand by volume. Data collected in 2011 indicate that the implementation of the filter socks had no impact on monthly soluble or total phosphorus concentrations and loadings in the east drain. Annual concentrations and loadings following the filter sock implementation are not available because we only have one year of post practice implementation. However, we have three years with the end-of-tile filter system. Like the filter socks, no discernible differences in monthly loadings or concentrations were
