Volume 7, Number 18
September 15, 2008

Long-term Monitoring of Nutrient Loss in Runoff from a Golf Course

Steve Starrett, Yunsheng Su, Travis Heier, Jamie Klein, Jeff Holste, and Mónica Paloma

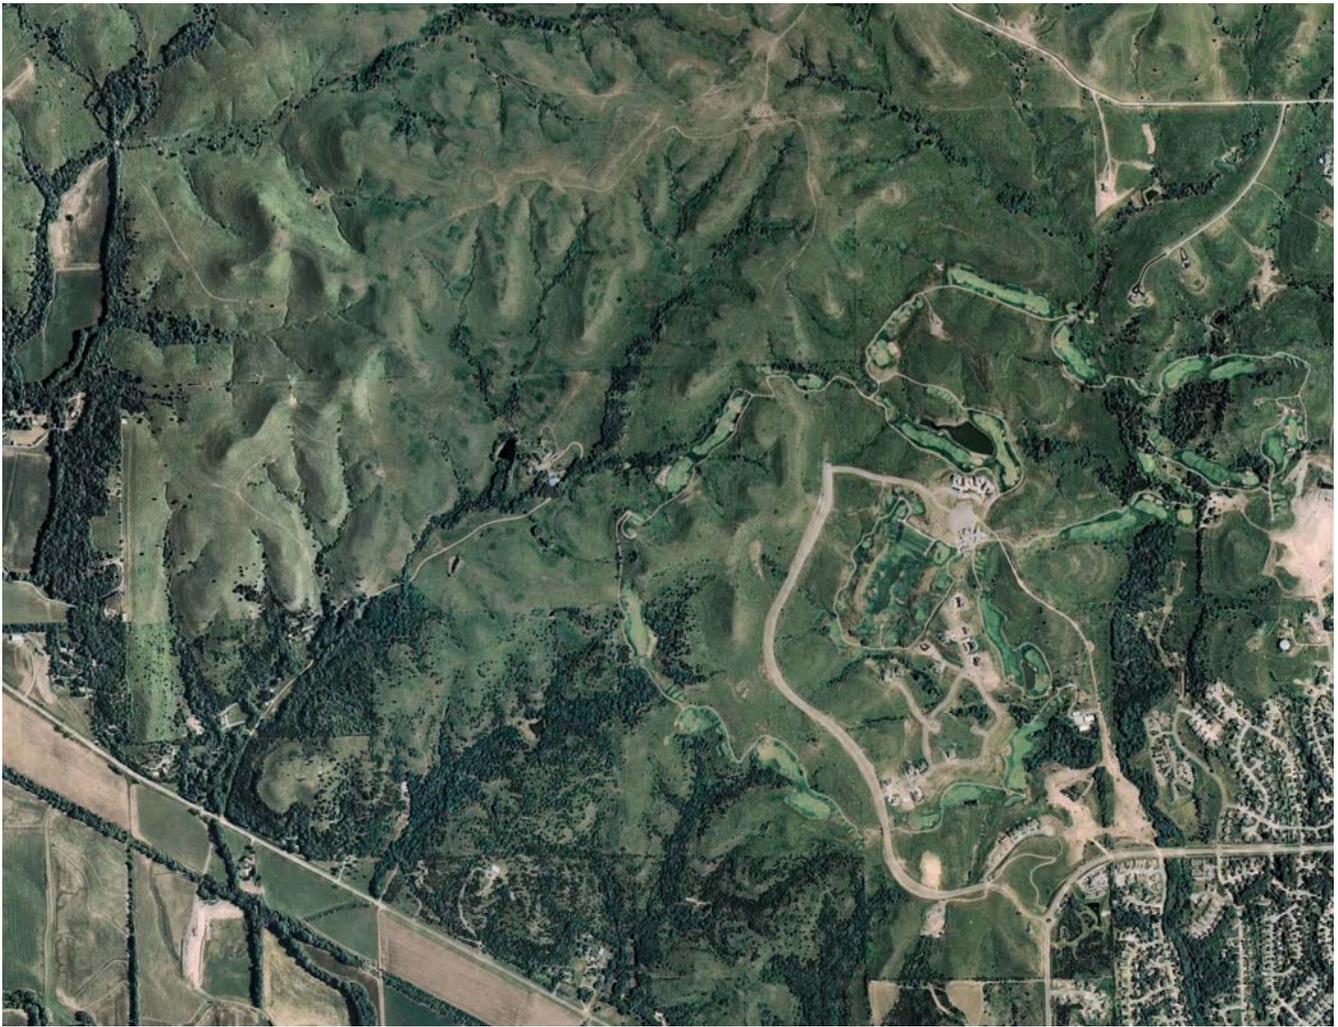
Figure 1. Aerial photo of Colbert Hills Golf Course, Little Kitten Creek Watershed, and the surrounding area. The undeveloped surrounding area represents the Colbert Hills Golf Course area prior to construction.

The watershed is located in southwestern Riley County on the west side of Manhattan, Kansas (Figures 1 and 2). The watershed, covering 430 hectares (1,063 acres), has a typical mid-west topography with elevations ranging from 420 to 340 meters (1,378 to 1,115 ft), decreasing from north to south. Land surface slope ranges from 0.04-0.14 (m/m) with an average channel gradient of 0.032 (m/m).

and woods with around 89% grasslands, 11% woodlands, and negligible residential lands (Figure 1). Construction of the golf course started in July 1998. By early 1999, alteration of land cover had attained its peak when about 88 hectares (20% of the total) of native cover was removed. By April 2000, the course was completed and disturbed lands were covered with grasses.

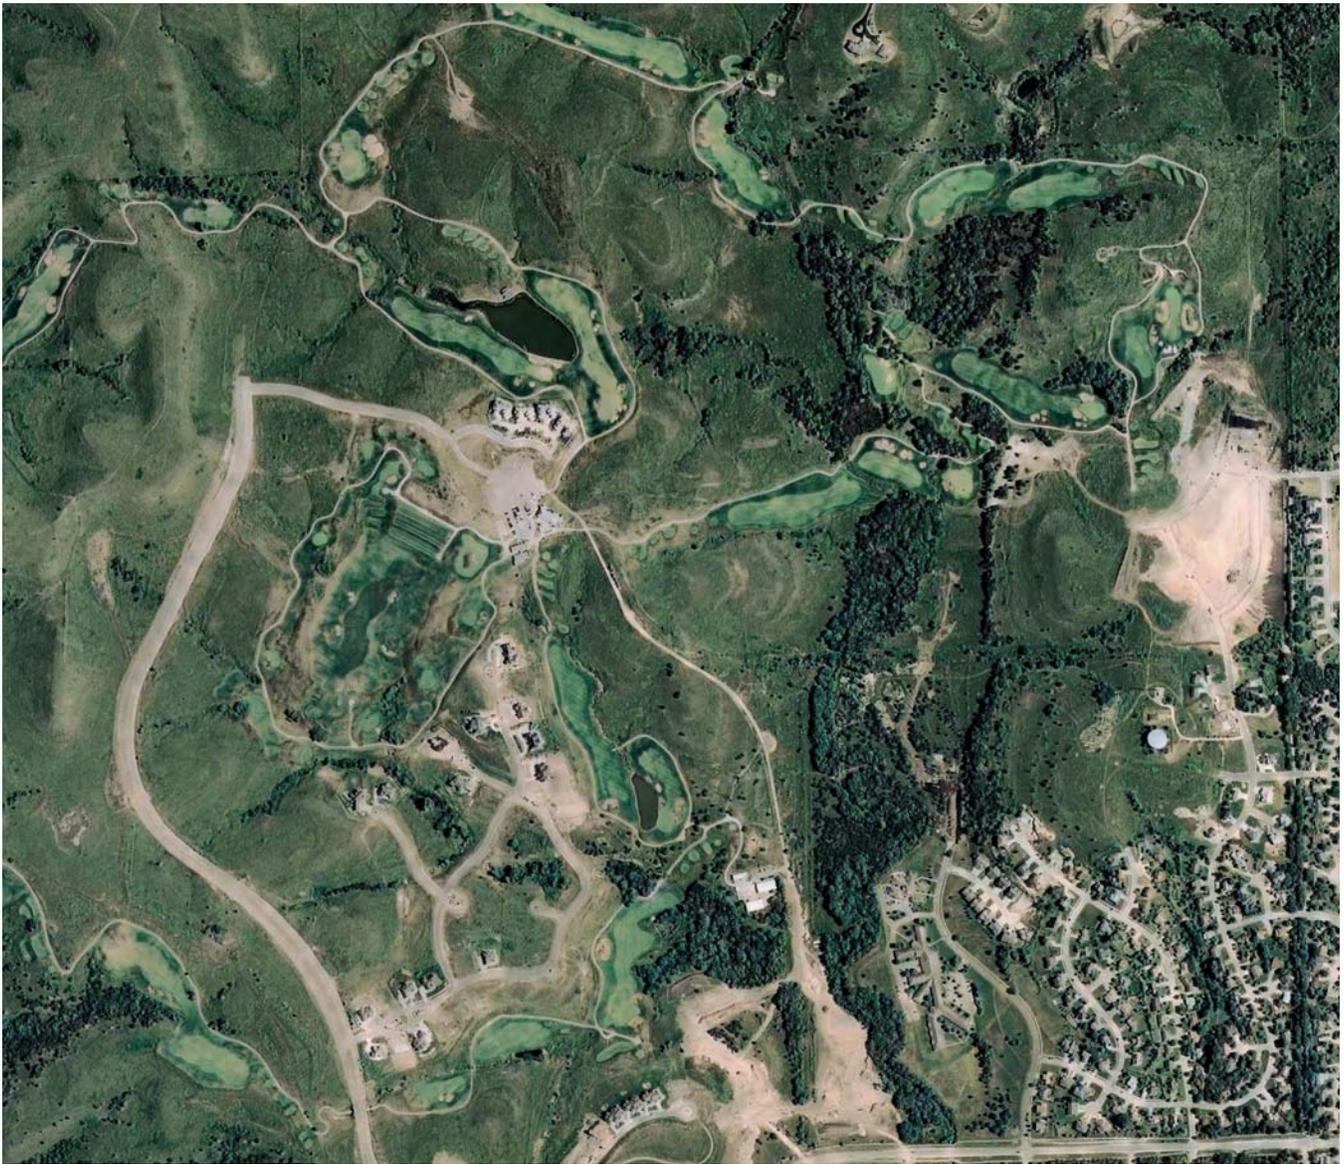
Figure 2. Aerial photo of Little Kitten Creek Watershed and Colbert Hills Golf Course area after construction (terraser.com)

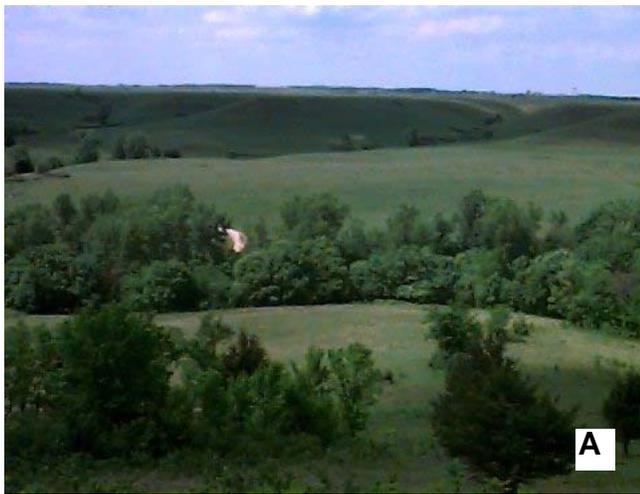
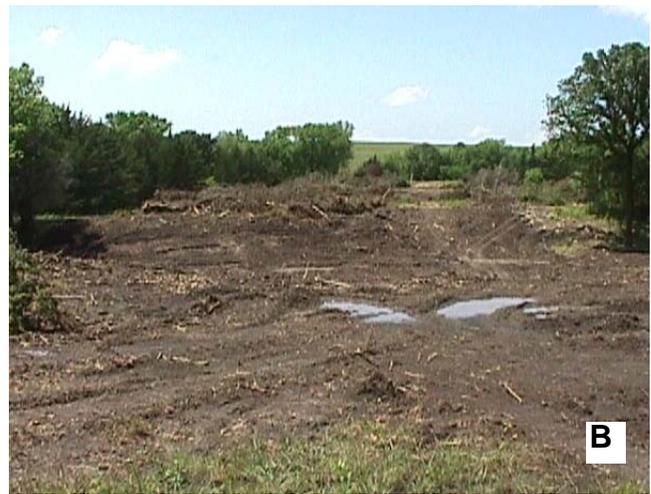
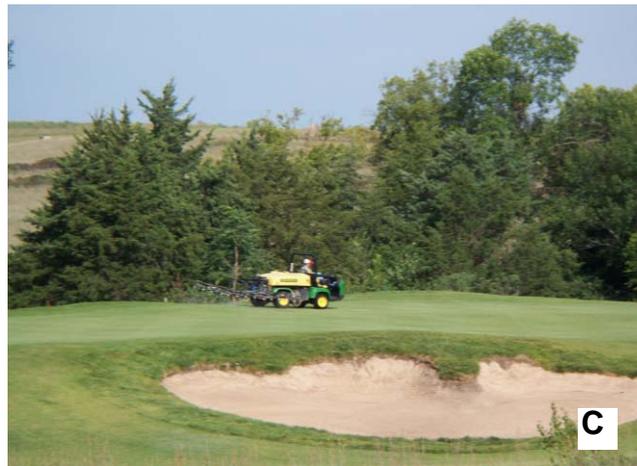
Figure 2. Watershed land management change over the 8-year term period: A) pasture coverage B) construction period, C) early operation of Colbert Hills Golf Course

Figure 2 illustrates the watershed conditions during the three different stages of management that the land experienced from 1998 to 2006. Figure 2A shows the pasture cover that the area had until 1998; Figure 2B illustrates the dramatic effect on the stability of the soil structure upon removal of the natural soil cover. The high potential for runoff and contaminant transport to surface waters, upon the occurrence of rain events, is significantly higher under such conditions.

Once the golf course turf has been established, the potential of surface water contamination through soil erosion and runoff decreases significantly. However, the application of fertilizer could represent a source of increasing nutrient transport to surrounding streams (Figure 2C).

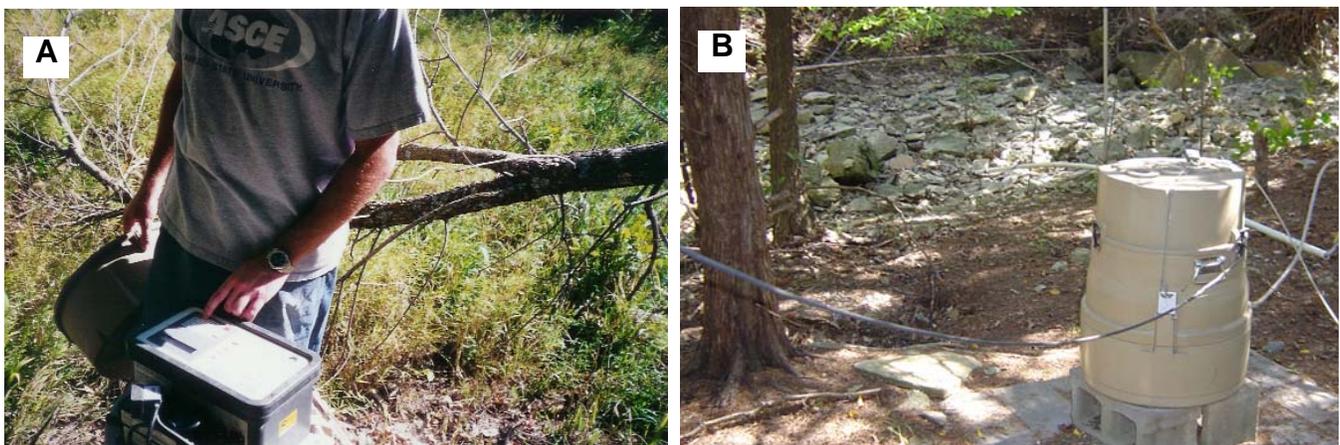
Figure 3. A) ISCO 3700 portable samplers and B) sampling station

ISCO 3700 portable samplers were set up at each of the three stations to collect water samples during runoff events (Figure 3A). Liquid detectors actuated the samplers at the beginning of a runoff event and the samplers collected grab samples at a pre-determined time interval of one or two hours (Figure 3B). Field sampling conditions did not allow inclusion of sample replicates as part of the study. Collecting runoff samples from almost all storms would produce higher constitute concentrations than a sampling method that collected samples every three months, for example. Thus, these sampling methods would capture the periods with the highest concentrations.

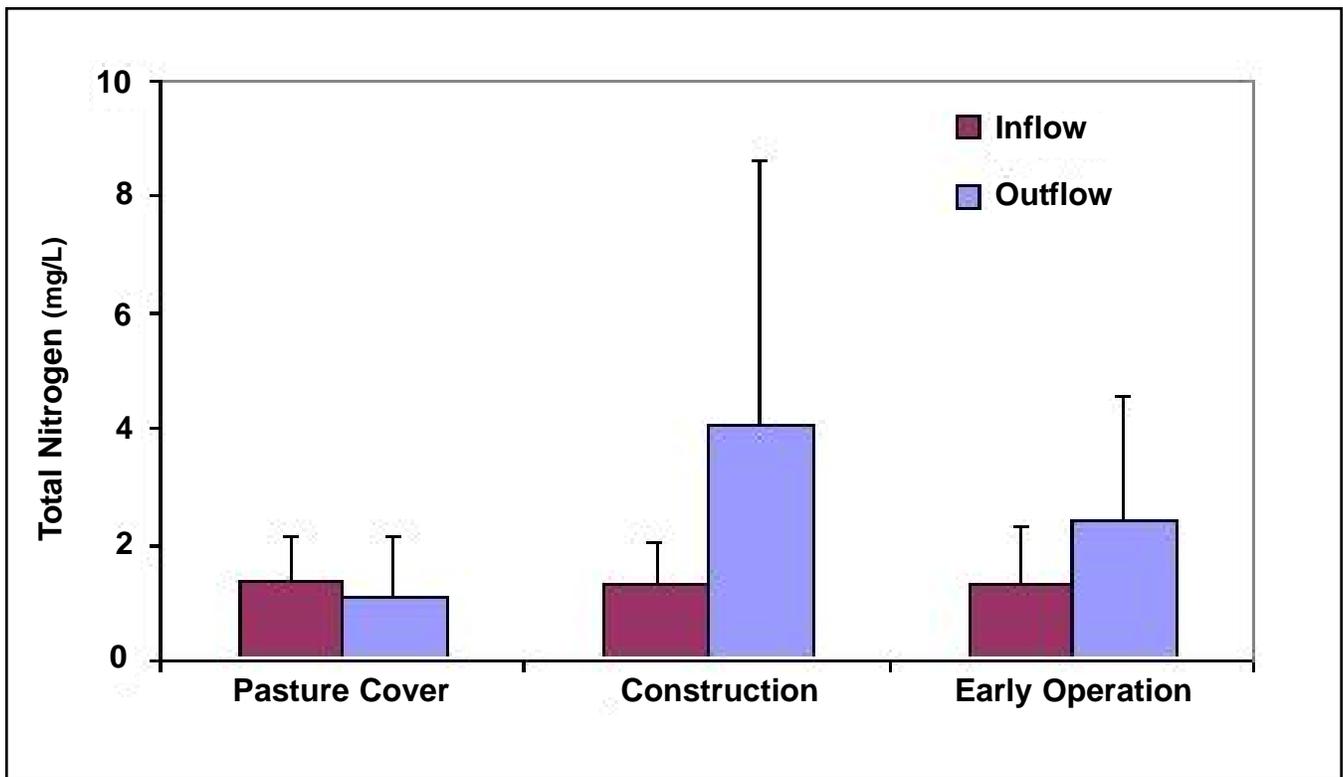
Figure 4. Total N (mg/L) measured in Little Kitten Creek entering and exiting Colbert Hills Golf Course during three stages of land development

Total N concentration during pasture cover, construction, and early operation stages is illustrated in Figure 4. On average 1.3 mg/L of total N was in Little Kitten Creek as it entered the golf course property during the eight years of study, the averaged value did not vary significantly during 1998 to 2006 early operation period. During the pasture cover stage, the total N concentration in the surface water entering and exiting the watershed was similar and not statistically different. This information is important to demonstrate that beyond the boundaries of Little Kitten Creek watershed there was no significant change in soil management that affected the incoming total nitrogen. However, the outflow data showed a different response than the total N concentration in the inflow.

measured total N concentration increased significantly in the surface water due to runoff, especially when heavy rainfall events occurred. An average of 4.0 mg/L total N was determined during the years of construction. The total N measured values exhibited significant variation. Importance of this result is that the concentration of total N in the stream during construction is sensitive to both soil management and weather condition.

The averaged concentration of total N in the outflow during the early operation stage (May 2000-October 2006) was observed to be smaller than that observed during the construction stage. An average concentration of 2.4 mg/L total N was determined. The standard deviation indicated that the magnitude of variation of the total N concentrations in the surface water decreased upon change of soil management, i.e., once soil vegetation cover was re-established. During the first six years of the golf course operation, a reduction of the total N concentration was observed. However, the early operation total N concentration was about double of the pasture cover total N value. Establishment of turfgrass required fertilization which was a potential source of total N in the watershed.

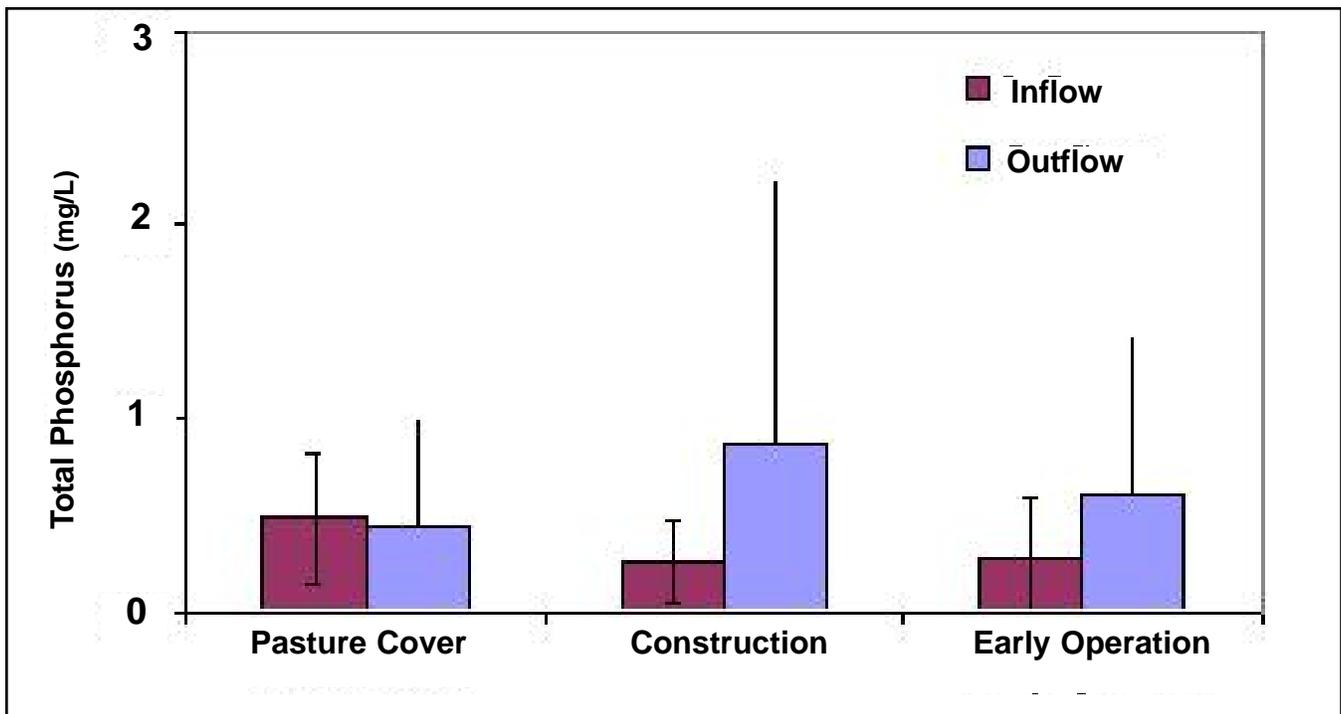
Figure 5. Total P (mg/L) measured in Little Kitten Creek entering and exiting Colbert Hills Golf Course during three stages of land development

The results for total P in the watershed inflow and outflow during eight years of study are illustrated in Figure 5. The total P in the inflow did not change significantly over the duration of this study. The inflow average total P values for the pasture cover, construction, and early operation stages were 0.49, 0.26, and 0.30 mg/L, respectively. During the pasture cover stage, an average value of 0.45 mg/L total P exited the watershed. Removal of soil vegetation cover increased the average value to 0.87 mg/L total P. Increase of total P concentration in surface water was due to erosion and runoff enhanced rain events, and lack of surface vegetation during construction period.
