Reducing Watershed Scale Phosphorus Export through Integrated Management USGA **Practices**

Kevin King, USDA-ARS James Balogh, Spectrum Research, Inc.

Turfgrass and Environmental Research Online

TERO Vol. 12(3):9-10 | May-June 2013 USGA ID#: 2011-11-421 TGIF Number: 222275

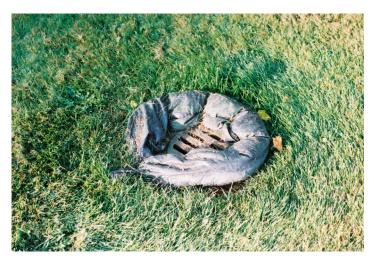
Figure 1. Filter socks were installed around drain inlets but had no impact on monthly soluble or total phosphorus concentrations.

In March of 2011, we initiated a paired study with the east and west drains and installed filter socks around each inlet within the eastern drainage area. The filter socks were filled with 75% steel slag, 2.5% cement kiln dust (CKD), and 22.5% silica sand by volume. Data collected in 2011 indicate that the implementation of the filter socks had no impact on monthly soluble or total phosphorus concentrations and loadings in the east drain. Annual concentrations and loadings following the filter sock implementation are not available because we only have one year of post practice implementation. However, we have three years with the end-of-tile filter system. Like the filter socks, no discernible differences in monthly loadings or concentrations were

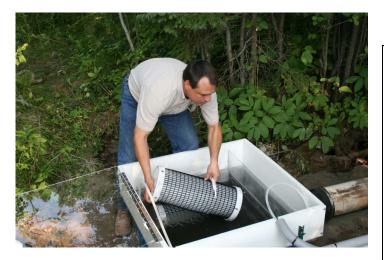
Figure 2. The inclusion of an end-of-tile filter system did produce a downward shift in annual phosphorus concentrations and loadings.

measured following the implementation of the filter system. However, when evaluated on an annual basis, a downward shift in both phosphorus concentrations and loadings was detected when compared to the period with no treatment. In 2012, phosphorus application in the eastern drainage area was limited. To date, the chemical analyses from those samples have been conducted but no interpretation of those results has been completed.
